SERVICE MANUAL

TR13-1 <u>13L TROLLEY SPRAYER</u> <u>SRVTR13-1 REV B - 22/10/2019</u>

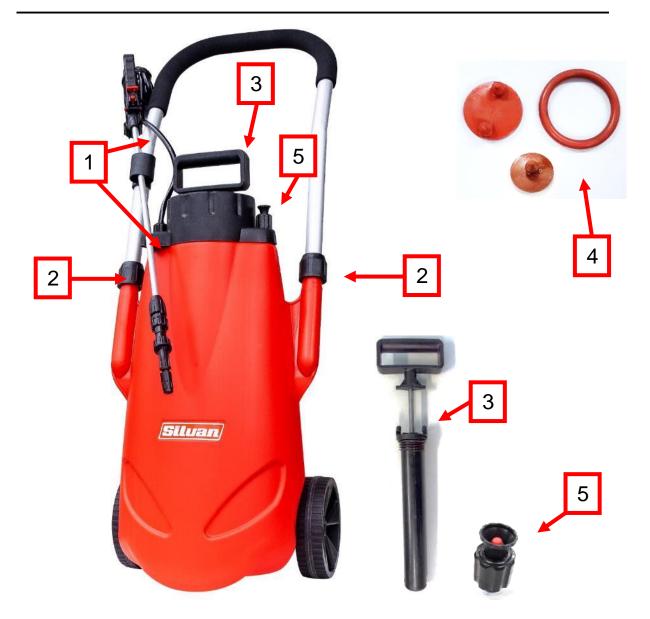
Problem	Solution		
The sprayer sprays air without water	<text></text>		
	<image/>
